The use of 'flight diverters' reduces mute swan *Cygnus olor* collision with power lines at Abberton Reservoir, Essex, England

SUMMARY

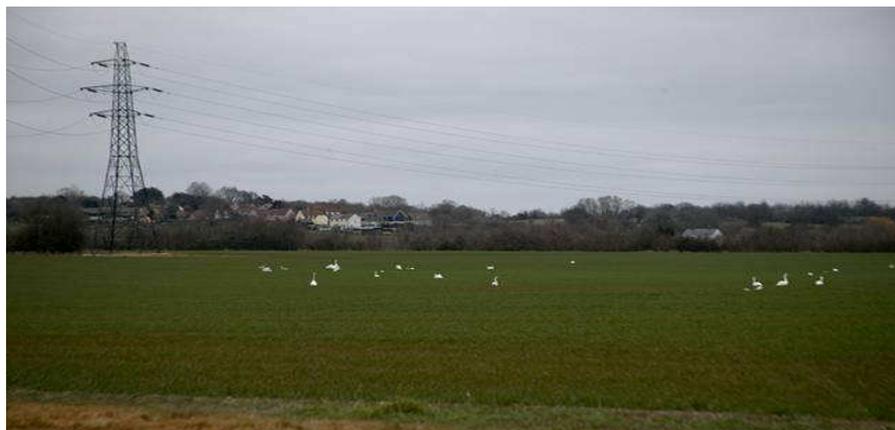
Figure 2. Mute swans feeding in cereal field adjacent to Abberton Reservoir with power lines in close proximity (© D.Frost www.eco-images.com).

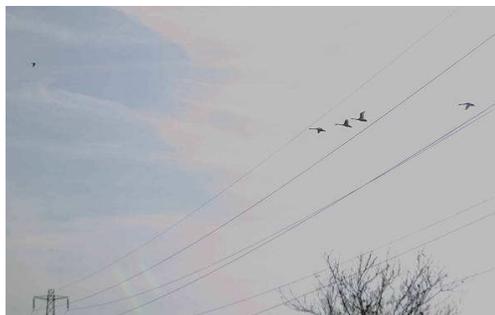
**Figure 4.** Mute swans flying over power lines. Note the seven wires with the thin earth wire at the top (© D.Frost www.eco-images.com).

Incidental observations indicated that upon their approach to the reservoir the swans flew at the same level as the main power lines. Frequently the swans saw the wires at sufficient distance enabling them to comfortably redirect their flight over the wires (Fig. 4). However, on many occasions the swans appeared to see the six main power lines when very close, resulting in the birds' taking rapid avoiding action. While the birds successfully manoeuvred over of the six main power cables, this brought them into close proximity of the earth wire, which is thinner and hence harder to see; this resulted in drastic evasive action causing the swans to almost stall in mid-air. While no observations of actual collisions were made, it is considered that the collision victims were birds that hit the earth wire rather than the main power lines. All observations were of birds flying over the power lines, with no attempts made to fly through or under the wires.

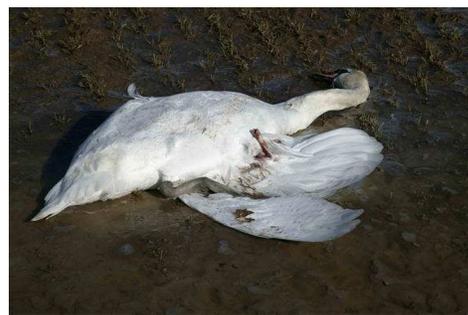
**Figure 5.** Adult mute swan with broken wing; carcass located some distance from the power lines; footprints and drag marks suggest death was not instantaneous (© D.Frost www.eco-images.com).

Mute swan injuries: The injuries to presumed power line collision victims found were varied but were consistent with collision injuries including broken wings and necks. Both

adults and juveniles were victims; while most of the dead birds recorded were adults (18 adults, six juveniles and seven of unknown age) the actual proportion of specific age groups could not be established due to the poor condition of some of the carcasses. There were signs to show that death was not always instantaneous, e.g. marks behind a carcass indicating that the bird had dragged itself along the ground for a few metres or more. Figures 5-6 show two dead mute swans associated with collisions with the power lines.

The distance at which swan carcasses were found from the point impact range from 10-351 m; some birds were clearly injured (rather than being killed outright) and able to crawl away from below the collision point before dying. This should be taken into consideration when identifying the appropriate area of coverage when developing future collision monitoring programmes.

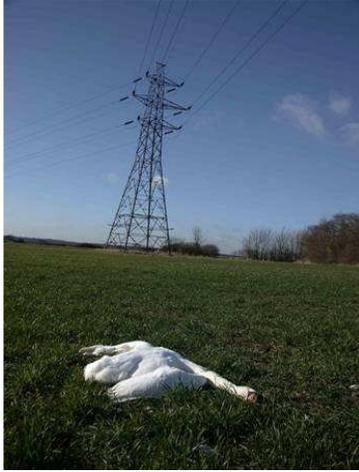
Figure 6. Adult mute swan showing signs of injury consistent with power line collision. Carcass located under wires suggesting instant death (© D.Frost www.eco-images.com).

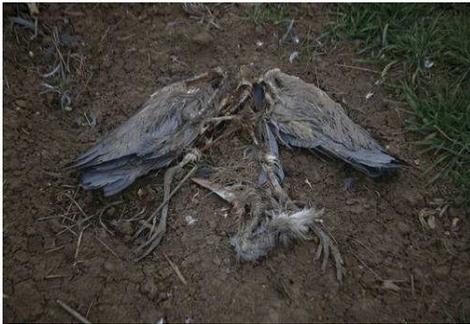
Figure 7. Carcass of grey heron another species vulnerable to power line collision at Abberton Reservoir (© Darren Frost www.eco-images.com).

Mute swans were not the only collision victims; carcasses of other species found were cormorant *Phalacrocorax carbo* (1), gadwall (1), tufted duck *Aythya fuligula* (1) and grey heron *Ardea cinerea* (1) (Fig. 7). The power lines were therefore causing mortality to a number of SPA cited species for Abberton Reservoir, not solely mute swan. The level of mortality being experienced by these other waterfowl remains unclear as they are smaller, have less obvious plumage colouration and are probably quickly consumed by scavengers, thereby reducing their rate of detection.

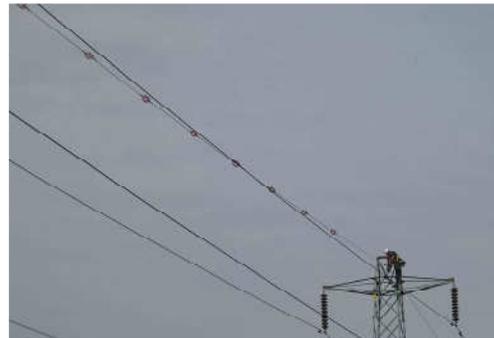
Figure 8. Bird deflector installation at Abberton, summer 2006 (© D.Frost www.eco-images.com).

approximately 500 spiral shaped bird flight diverters, at 5 m intervals to more than 1.5 km of the earth wire along the top of the 132kV overhead power line network at the western end of the reservoir. The aim was to increase the visibility of the earth wire. This task required diverting the electricity away from the overhead power lines, lowering the earth wire that runs between the top of each pylon and then hand fitting the spiral bird flight deflectors to the wires (Fig. 8).
